NDE2002 predict. assure. improve.
National Seminar of ISNT
Chennai, 5. - 7. 12. 2002
www.nde2002.org

Inservice Inspection of Steam Generator and Secondary Sodium pipe line welds of FBTR using Ultrasonics

Indira Gandhi Centre for Atomic Research
Kalpakkam

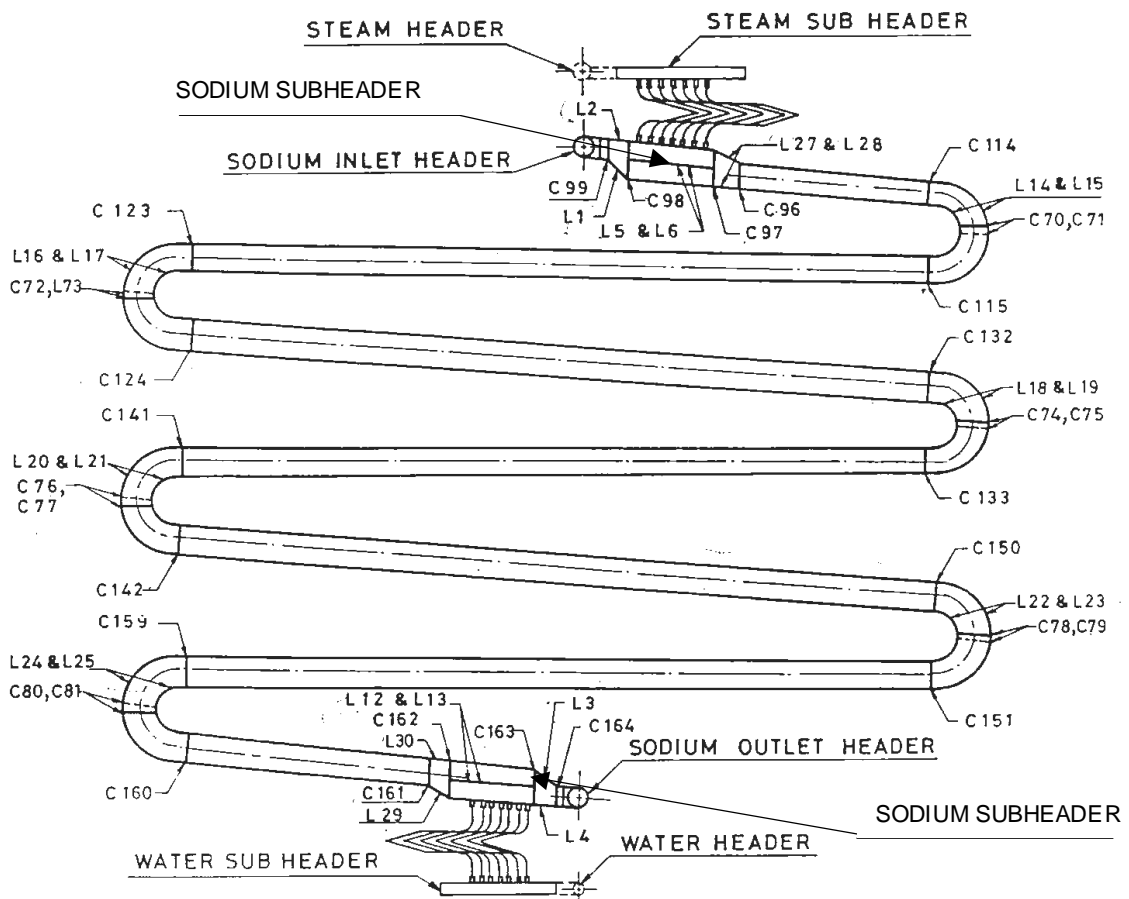
FIG 2 STEAM GENERATOR MODULE

The examination of shell welds of SGs was carried out after draining of sodium from the modules and then opening of SG casing. 100% of dissimilar weld joints and 30% of shell welds in all the 4 modules were ultrasonically tested. The OD of SG shell is 193.7 mm and WT is 8 mm. The location of all shell welds & dissimilar welds is shown in Fig. 2.

So far all the 8 dissimilar weld joints and 72 shell weld joints in all the 4 modules were inspected using ultrasonic angle beam technique. No indication / defects were observed in dissimilar joints. In some of the circumferential shell weld joints (return bend to shell joints) indications equivalent to the reference levels were observed when scanned from one side and indications were not observed from the other side. Based on the location of the indication in the weld joint and these were observed only from one side, it has been concluded that these indications may be due to excess penetration on return bend side or

due to geometry. During subsequent ISI also same observations were noticed without any change in size or amplitude. It was further decided that during all future ISI, these joints will be monitored. No defects or indications were observed in other joints.

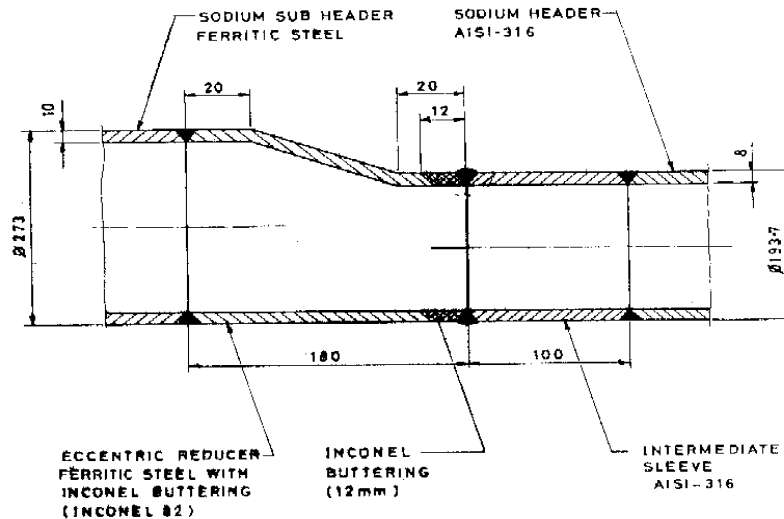
FIG. 3 DISSIMILAR WELD JOINT DETAILS.

The SG shell is made of 2 ¼ Cr, 1 Mo ferritic steel and sodium headers are made of AISI 316 steel. The SG modules were connected to sodium headers through an intermediate sleeve made of AISI 316 stainless steel welded to SG shell ends, which were

buttered with Inconel for about 12 mm. There are 2 dissimilar welds (one at the top and one at the bottom) for each of the 4 modules. Weld Nos. C 99 & C 164 are the dissimilar weld joints (Fig. 2).
